Hercules Engine News

Imperfections Detailed

Almost every engine reconstruction project requires modification to compensate for damage, missing parts or poorly fitting parts. Such is the case with my Hercules look-alike, Plessisville engine no. 2750.

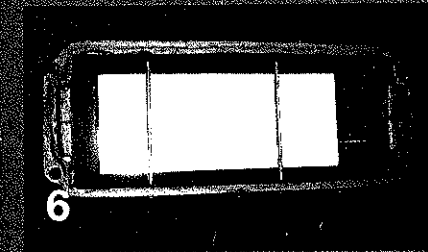
Another surprise came when it was time to put the fuel tank in the engine base. The tank for the normal small block Hercules would not fit. This required making a new tank with slightly smaller width and height dimensions. Photo 6 shows the new tank installed.
