# Hercules Engine News

## Model S Changes

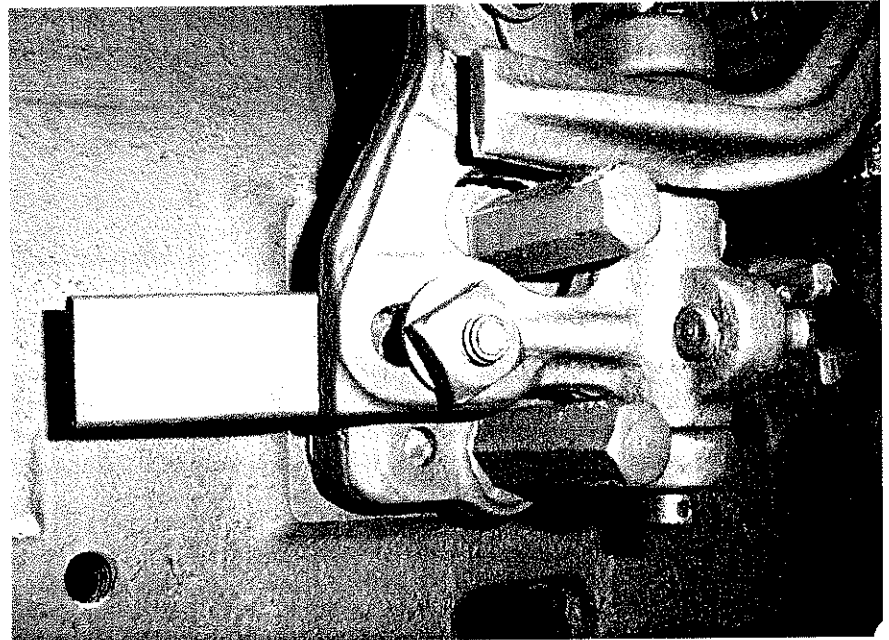
Photo #1: Threaded hole below detent blade and long-headed bolts securing governor mechanism.

Photo #1 shows a few interesting modifications. Close inspection reveals a 3/8-inch threaded hole just below the end of the detent blade. This is where the fuel spout brace attached on the 2 HP Jaeger brand engines. The oblong hole below the detent mechanism is where the governor arm on the throttling-governed Model SK Hercules engines went through to attach to the rod to the fuel mixer. The other feature is the two, long-headed bolts that hold the governor mechanism to the side of the block. Gone are the awkward-to-reach, slot-head screws that hid behind the flywheel rim on earlier engines. These newer bolts permitted the use of a 1/2-inch open-end wrench instead of an

ill-fitting screwdriver. Additional clearances were made in the detent casting to allow enough room for the bolt heads.

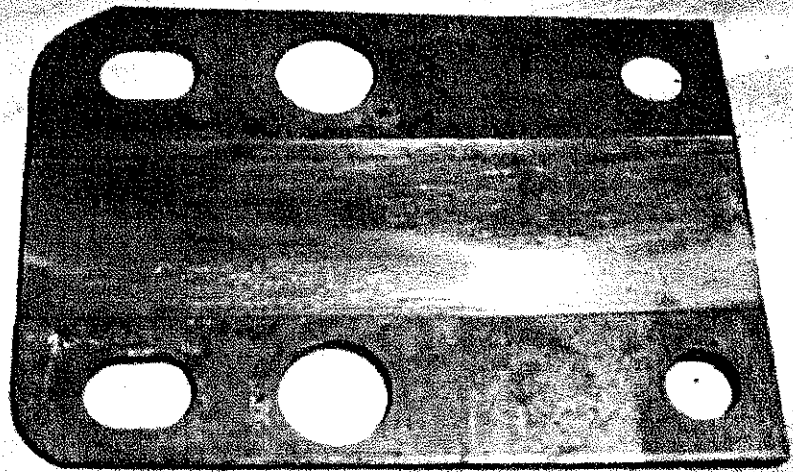
Photo #2: Reversible wear plate for governor bracket.

Photo #2 shows a reversible wear plate that fit in between the

governor bracket and the side of the block. It is about 1/16-inch thick, and I assume that material had to be machined off the block where the governor mounts to accommodate the thickness o

the wear plate. Before the use of this plate, the side rod would wear a groove directly into the side of the engine block surface, causing the side rod to gradually twist out of the correct position.

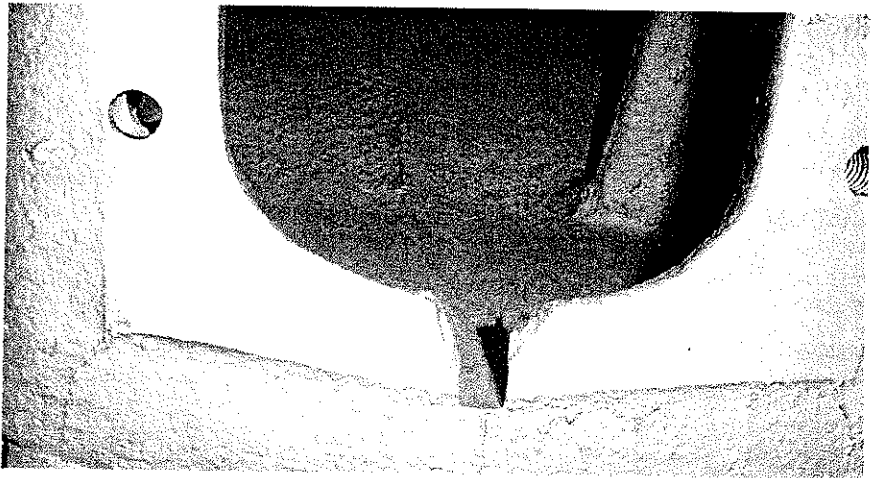
*Photo #3: Notch machined in rear of crankcase to allow excess oil to run out of the back of the engine base.*

Photo #3 shows the rear of the crankcase area, and a notch that has been machined in the lip to allow accumulated oil to run out of the back of the base. The notch allowed excess oil to run out onto the ground instead of forming a puddle under the crankshaft.

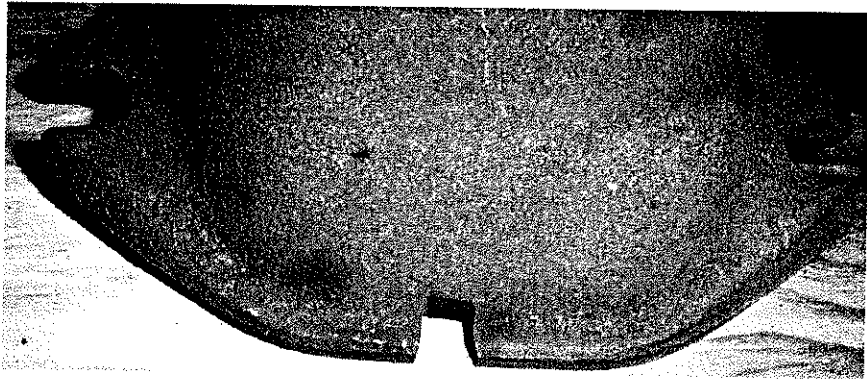
*Photo #4: Corresponding notch cut out of rear of crank guard to line up with notch in crankcase*

Photo #4 shows the Hercules crank guard with a corresponding notch machined into the lower lip to match up with the crankcase slot.
